**BART CLIPS
DERAILMENT - 9/10**

BART ISSUES FINAL REPORT ON 1992 DERAILMENT

APPENDIX 2
TRACK LAYOUT AT SWITCH #153 OAKLAND WYE

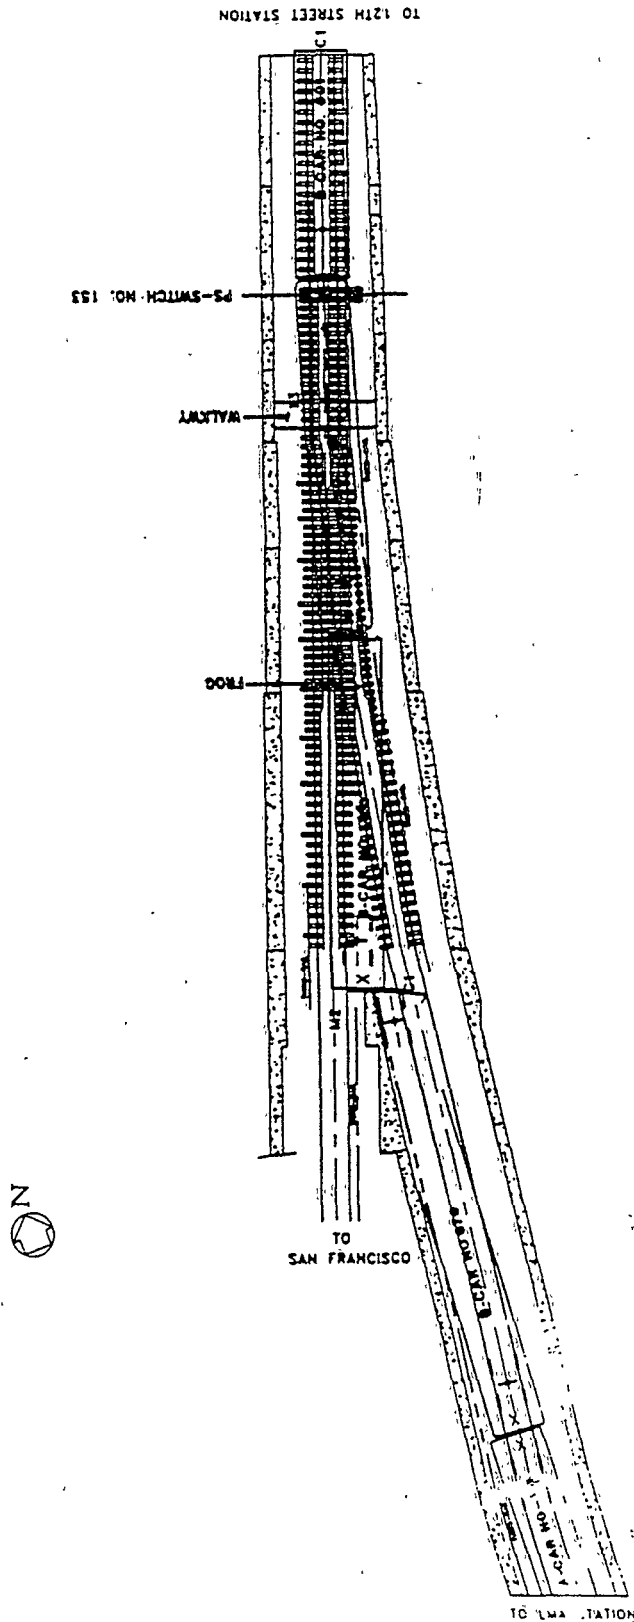
The derailment occurred when the lead truck of car #753 derailed and pulled the trailing truck of car #676 off track C1 at switch #153. Examination of the accident site revealed that the right-hand switch point and stock rail were severely worn. At a point 18-24" south of the point of switch, the #2 wheel, which also was severely worn, climbed the switch point and rode along the top of the stock rail before falling onto the road bed and continuing to travel along track M2 in a derailed condition.

The American Public Transit Association Panel of Inquiry believes the probable cause of this accident was that wheel #2 of car #753 climbed the right-hand switch point of switch #153 and derailed.

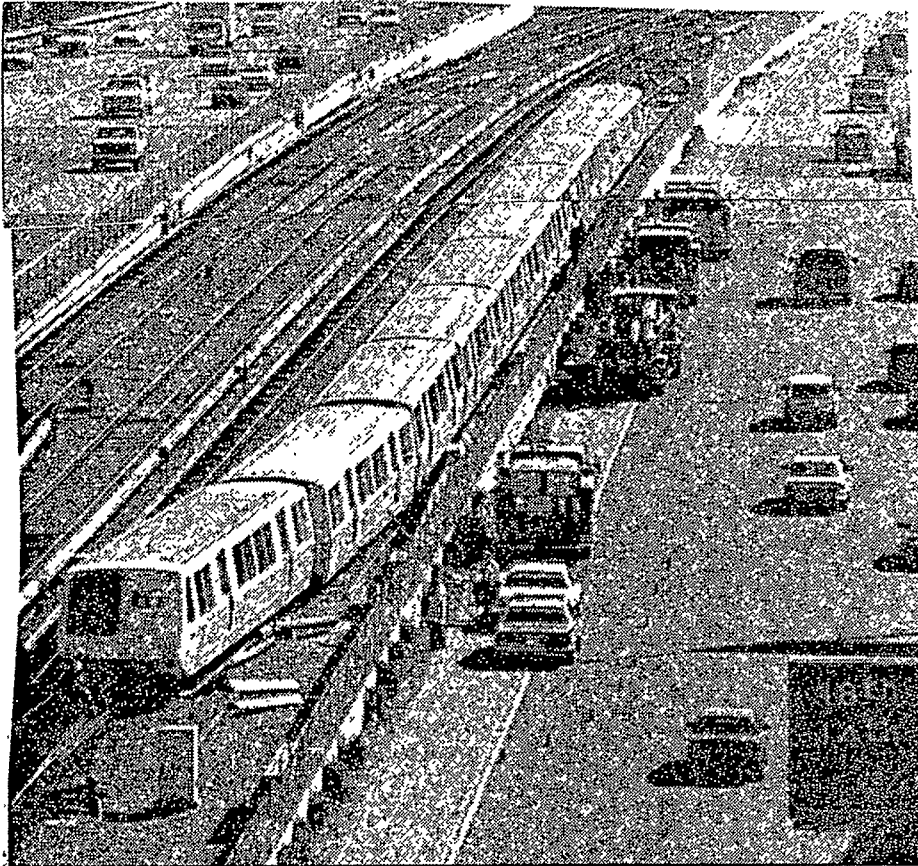
The last two cars of an empty 10-car BART train derailed Friday afternoon near 27th Street in Oakland, sparking two small fires.
